**FIELD REPORT:
2014 USS *HOUSTON* (CA-30) DIVEX**

Underwater Archaeology Branch
Naval History and Heritage Command
Department of the Navy
10 November 2014

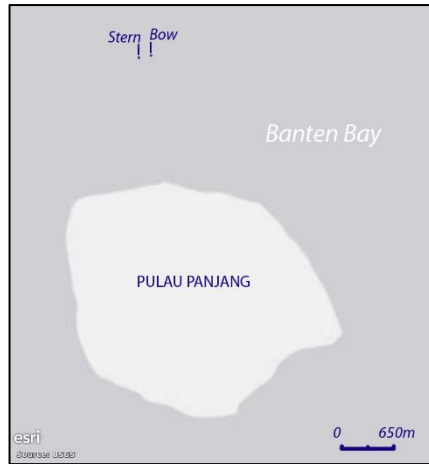
Figure 4. GPS coordinates of extremity buoys for precise location and orientation.

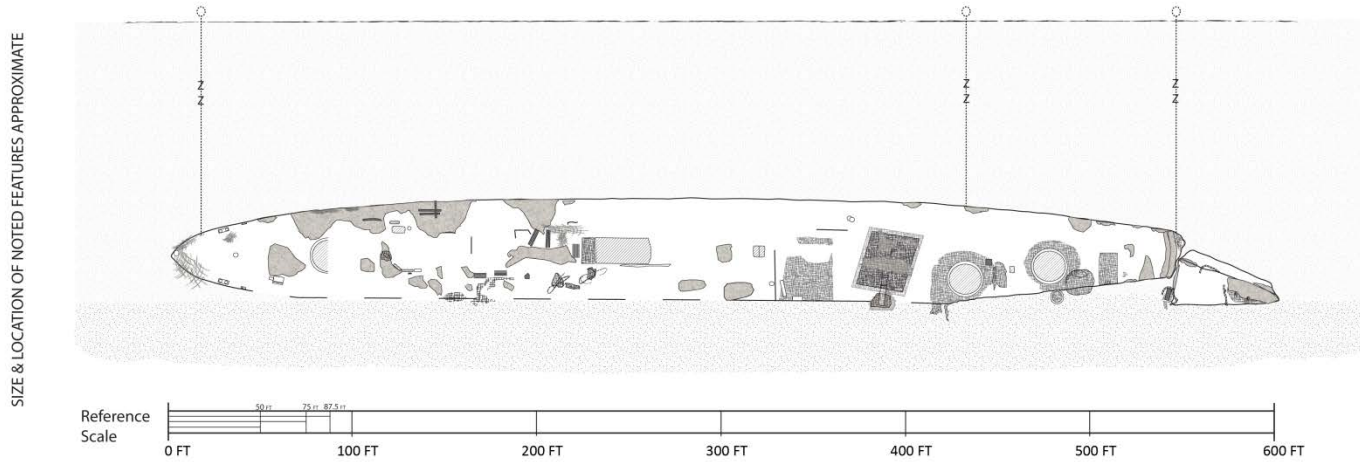
The data collected during the DIVEX indicated that the hull's starboard side is lying on the seafloor, with the deck positioned perpendicular to the seafloor facing towards shore and the entire port side exposed. A notable break appears near the bow, approximately 40 ft (c. 12 m) aft of the damaged tip. Battle damage, damage associated with the wrecking event, and subsequent disturbance of the site appear to have severely disfigured the vessel. Fishing nets, strewn throughout the hull and particularly prominent in the vicinity of the stern and along amidships, obscure many of the vessel's features. Figure 5 presents a comprehensive site plan based on features observed during review of video recordings and concurrent assessment of all other project-derived data such as diver logs and side-scan sonar records.

Figure 5. Site plan identifying features and site damage observed during data analysis phase. (A) represents a bird's eye view of the port exposed side of the vessel, while (B) represents a profile view of the hull as it rests on the seafloor.

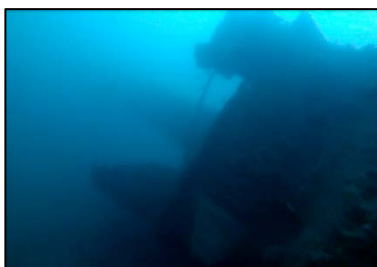
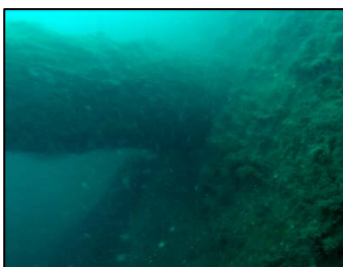
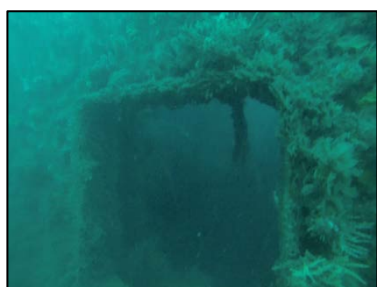
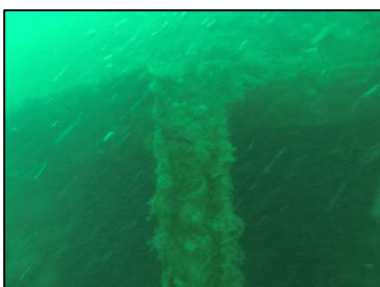
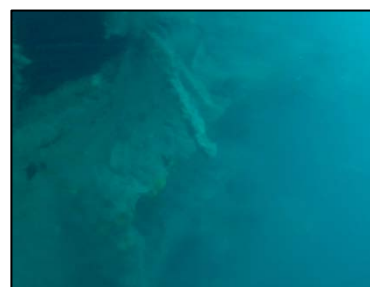
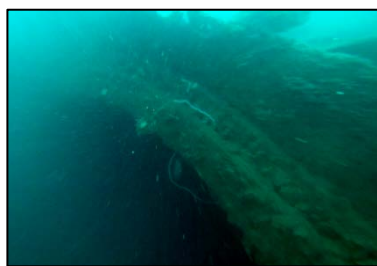
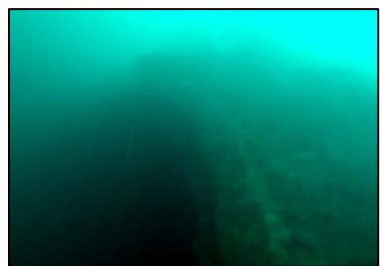
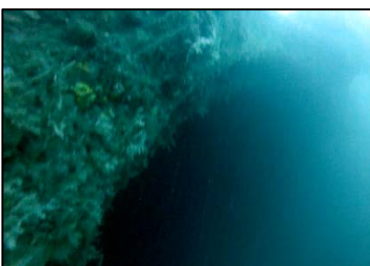
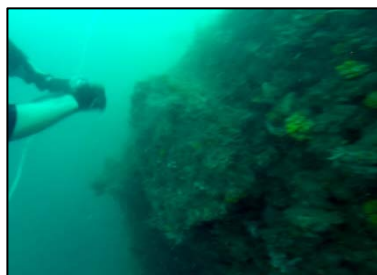
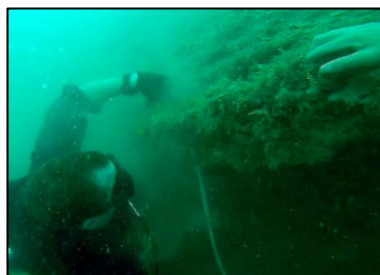
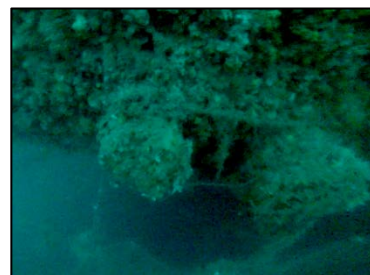
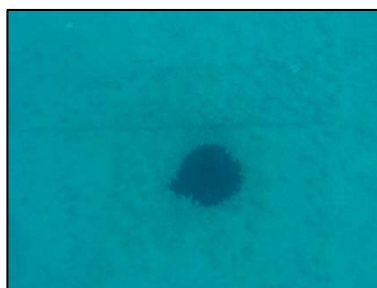
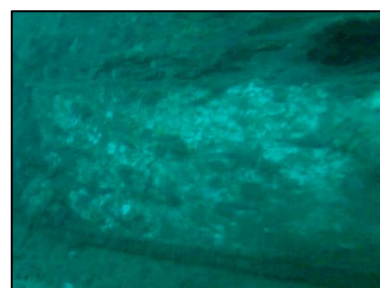
Figure 7. Screen shots from video recordings of identifiable features: (A) foretop fire control station with two stumps and the centerline leg; (B) port foremast stump; (C) forward hatch; (D) midships hatch; (E) stern hatch; (F) turret 1 casing; (G) turret 2 casing; (H) turret 3 casing; (I) stern bit; (J) stern chock; (K) stern double cleats; (L) sample porthole; and (M) hexagonal tile in washroom near base of mainmast.

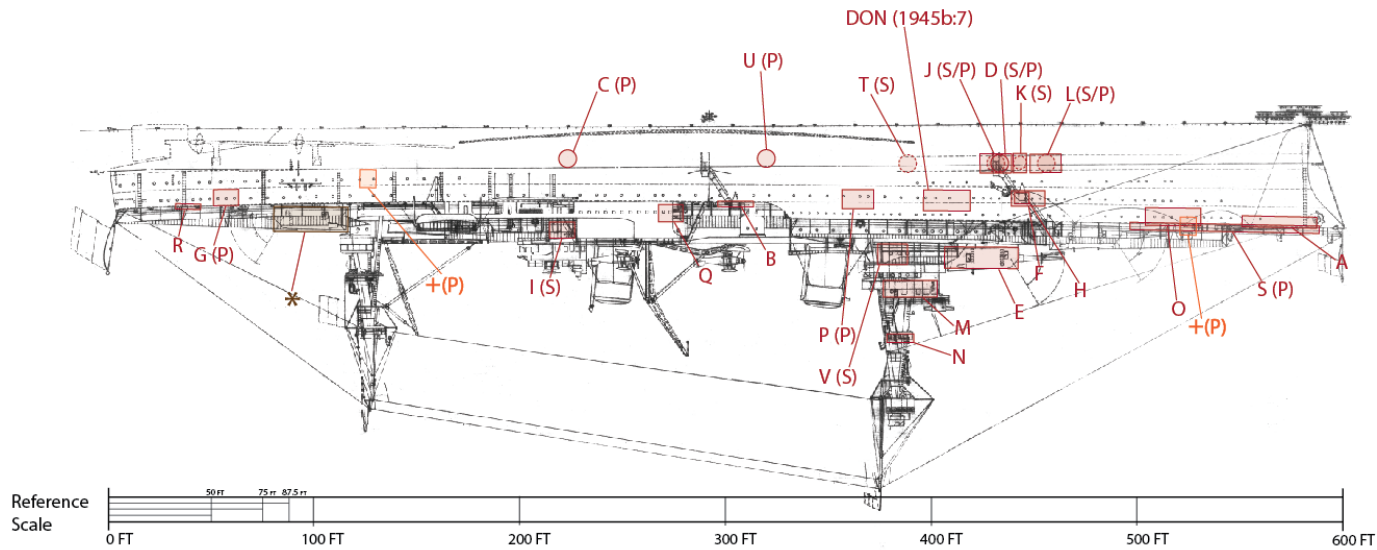
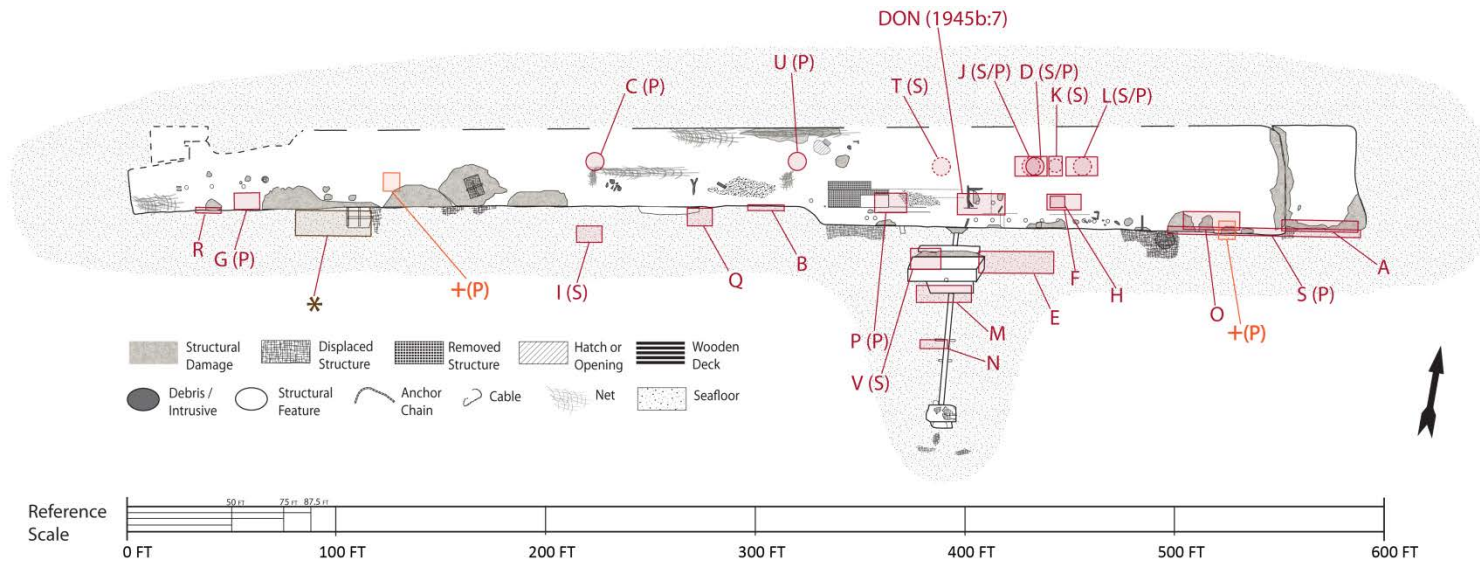
There is particular evidence of battle damage that corresponds directly with the action report filed in 1945 by former gunnery officer Arthur Maher (DON 1945b), the senior survivor of USS *Houston*, which also correlates with eyewitness accounts presented elsewhere (e.g. Holbrook 1981:83-102). Table 2 is an excerpt from Maher's action report recounting the shell and torpedo hits *Houston* sustained. Figure 8 illustrates the impact areas superimposed on both the original ship drawings as well as on the site plan of the wreck site, indicating a series of correlations with the action report. Figure 9 provides images of hull impacts identified during the DIVEX and believed to represent battled damage.

area of the main wardroom (Fig. 8 DON 1945b:7/Fig. 9(E), (F)), and near the stern (Table 2/Fig. 8 G, R). Additionally, what appear to be two torpedo hits are visible on the wreck in the vicinity of reported torpedo hits (Table 2/Fig. 8 U/Fig. 9(G), (H)). Finally, damage observed on site may also be the result of earlier engagements, such as the Battle of the Java Sea (e.g. Fig. 8 **/Fig. 9(B)).

Figure 8. Approximate areas of shell or torpedo hits received by USS Houston superimposed on original ship drawings (above) and superimposed on the top view site plan (below). Hits sustained during previous engagements are indicated by symbols (*: Battle of the Flores Sea; +: Battle of the Java Sea). Damage sustained during the Battle of Sunda Strait is indicated by letters, which correspond to Table 2. Letters in parentheses indicate the side of the vessel receiving the strike, when known (P: port; S: starboard).

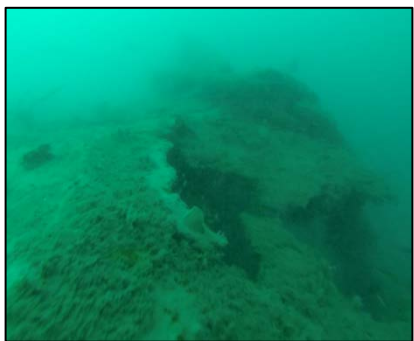
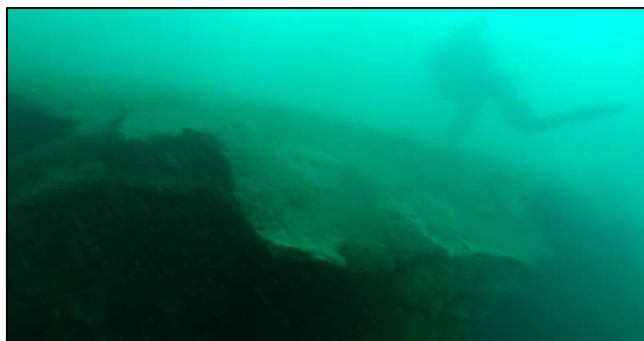
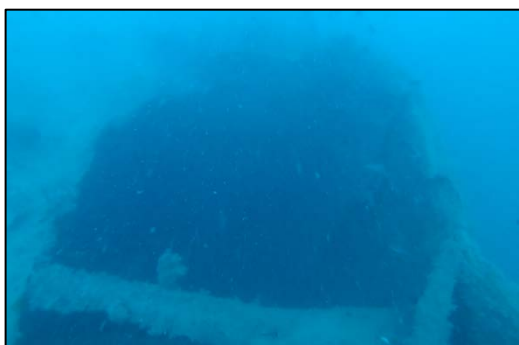
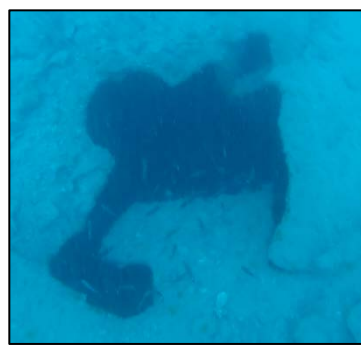
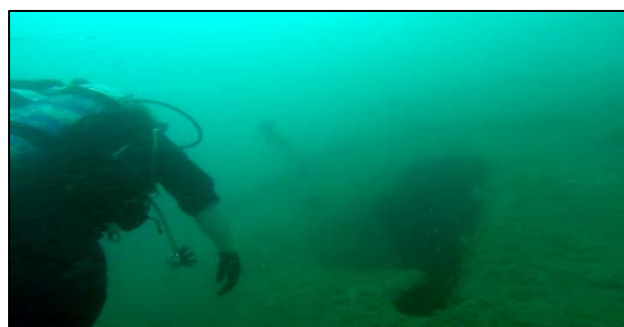
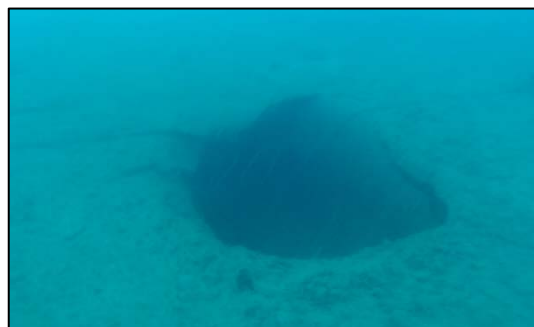
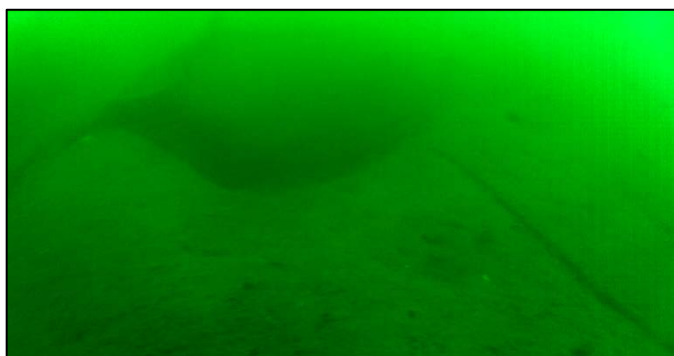
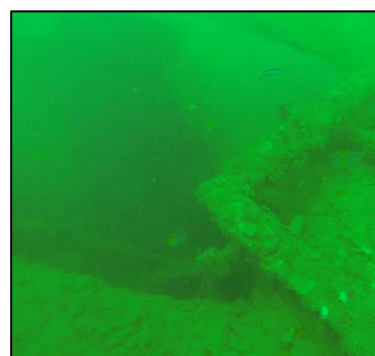
Figure 9. Screen shots from video recordings of hull impacts presumed to be associated with battle damage, as designated in Table 2/Figure 8: (A) shell damage in vicinity A, S; (B) shell damage in vicinity O, S, *; (C) shell damage in vicinity F, H; (D) shell damage in vicinity F, H; (E) shell damage in vicinity of wardroom; (F) shell damage in vicinity of wardroom; (G) torpedo damage in vicinity U; and (H) torpedo damage in vicinity of U with nearby dredge and rectangular frame.

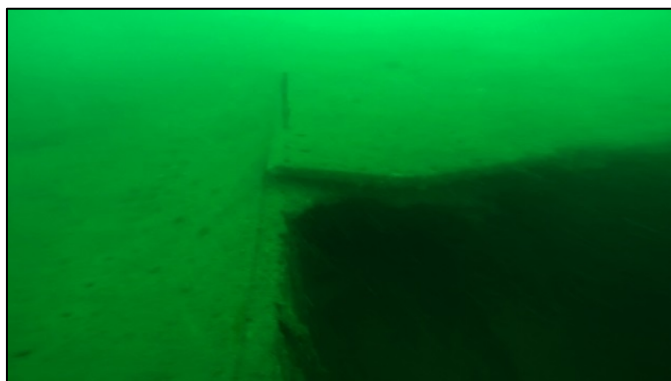
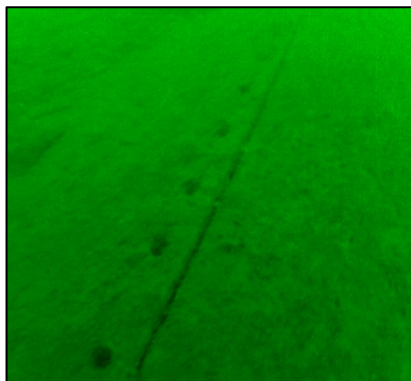
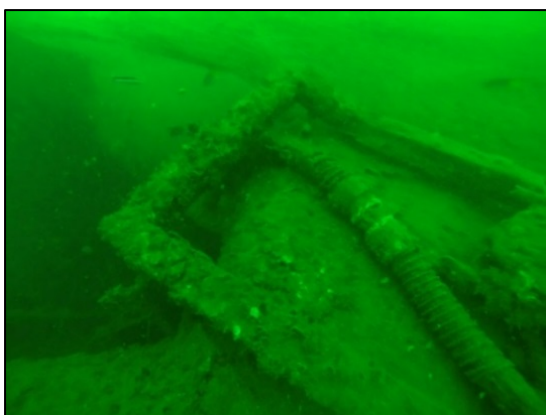
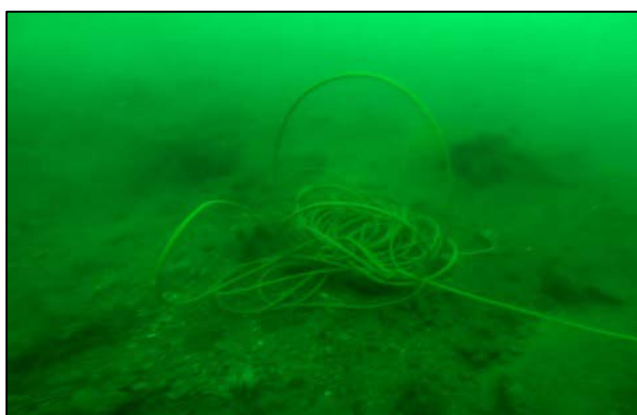
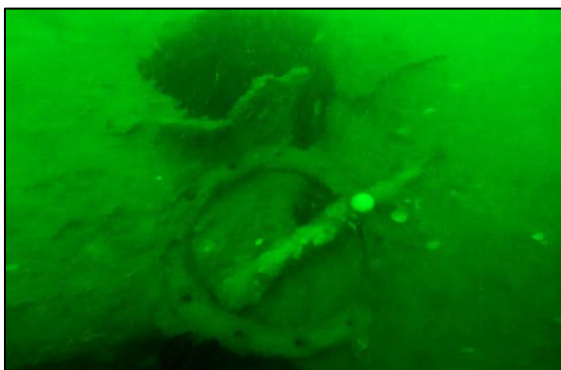
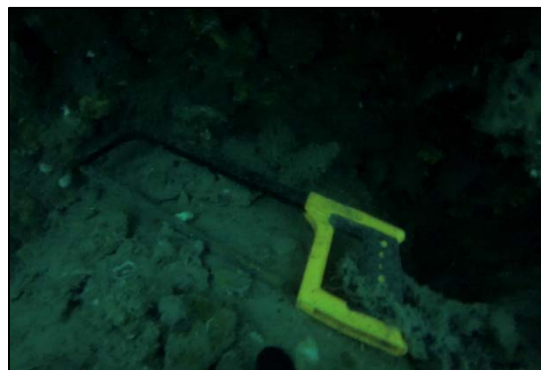
Rivets running along the edges of seams holding hull plates together have been methodically removed to allow for the plates to be maneuvered and lifted as part of unauthorized recovery operations. Figure 11(A) shows a gap between a plate that has already been removed and the initial lifting of the adjacent plate. The marker standing upright in the center of the image is placed on the last rivet that has been removed along the seam. Figure 11(B) shows a seam between metal hull plates with rivets removed along one side. Sequential removal of rivets was observed in multiple areas of the exposed port side of the hull.

Areas of the port side of the wrecked vessel have caved in or been deformed by extensive battle-related damage. Figure 11(C) shows what appears to be a water-dredge, used to remove sediment from an underwater environment, adjacent to such a cavity resulting from a presumed torpedo hit, permitting access to the interior of the hull. Dredges of this type are commonly utilized in salvage or archaeological

operations to excavate through and remove compacted sediment. The condition of the dredge indicates it has been present on site for some time, while it is still being weighed down by a rectangular metal frame and what may be an adjacent cinder block, suggesting its continued use.

A modern hollow hose was observed coiled near the stern on the exposed port side of the vessel (Fig. 11(D)). The hose's loose end heading away from the coil was not traced as dive time was limited. The hose, through which compressed air can be pumped down to the seafloor for breathing purposes, is apparently consistent with the type of rudimentary surface-supplied diving system that local divers use to support prolonged underwater operations.

The vast majority of portholes on the exposed port side of the hull have been removed; what remains is typically evidence of forceful removal in the form of a circular gap in the hull. Figure 11(E) shows a custom-made tool constructed for such a purpose, alongside a rubber gasket that once formed part of a porthole seal near a disfigured porthole. Divers observed that the tool utilized a handle made of a golf ball.

Adjacent to the base of mainmast of the vessel, divers observed and recovered a hacksaw visible in Fig. 11(F). The condition of the hacksaw indicates that it was a very recent intrusive addition to the site, as there were no visible signs of corrosion on the metal blade.

Figure 11. Indications of unauthorized disturbance on exposed port side of the vessel as observed during the 2014 DIVEX: (A) interface between removed hull plate and subsequent plate still in position; note marker (center) indicating the last rivet to have been removed in the seam; (B) seam between hull plates where rivets have been systematically removed on one side; (C) water dredge being weighed down by metallic frame with one end resting within a cavity resulting from a presumed torpedo hit; (D) coiled yellow hose presumably utilized for basic surface-supplied diving operations; (E) evidence of a porthole gasket lying adjacent to a deformed porthole and a tool with a golf-ball handle ostensibly utilized for porthole removal; and (F) a hacksaw recovered from the site adjacent to the mainmast area.

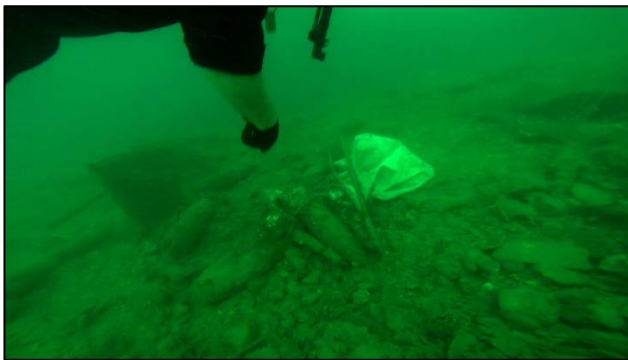
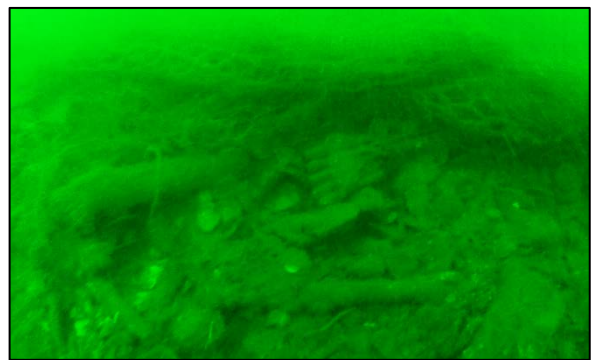
Divers observed an accumulation of shells and ordnance resting on the exposed port side of the hull alongside a secured bag, likely placed there in preparation for their recovery (Fig. 12/ Fig. 13(A)). Given the location of this accumulation, it is not deemed to be a natural collection but rather evidence of the unauthorized removal of presumably live ordnance from the site. What may be a second

artificial accumulation is located in the vicinity of the observed water dredge (Fig. 13(B)). Elsewhere, what appear to be individual casings, shells, and other ordnance are dispersed in several locations across the port side of the hull (Fig. 12). As no assessment has been conducted on any of the seemingly intact pieces of ordnance, any such ordnance must be presumed active, and therefore potentially a public safety hazard.

Figure 13. Shell casings or ordnance on the exposed port side of the hull: (A) accumulation adjacent to a secured bag likely intended to aid in expected recovery; (B) accumulation held in place by nets near the water dredge observed amidships.

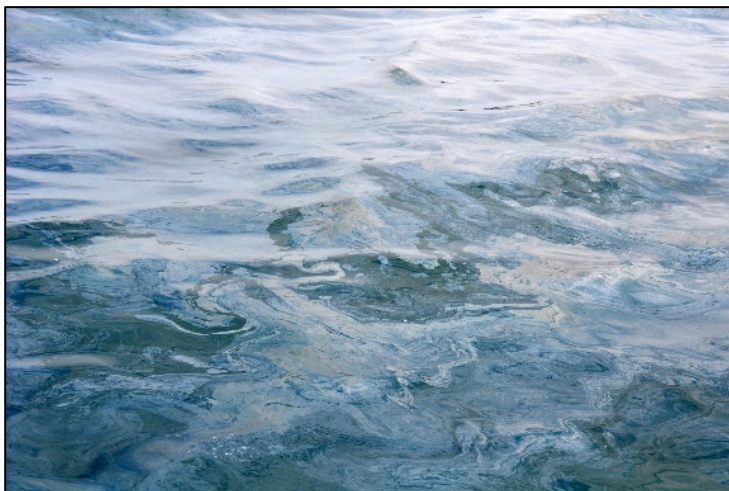
Figure 14. Oil sheen concentrated over the DIVEX area of operations.

The presence of oil slicks on the surface of the water above and around the DIVEX site was noted by multiple project participants and observed in numerous locations scattered several hundred feet apart over the vessel. The first evidence of oil in the water column was recorded by the side-scan sonar team as the towfish was being recovered on 10 June. Subsequently, slicks and active seeps were witnessed during the mornings of 11, 12, and 13 June when the sea surface was calm. Figure 14 shows a moderately sized sheen that accumulated in the vicinity of USNS *Safeguard*. Figure 15 shows one of several small oil seeps in the adjacent area as the oil reached the water's surface and expanded, forming a sheen.

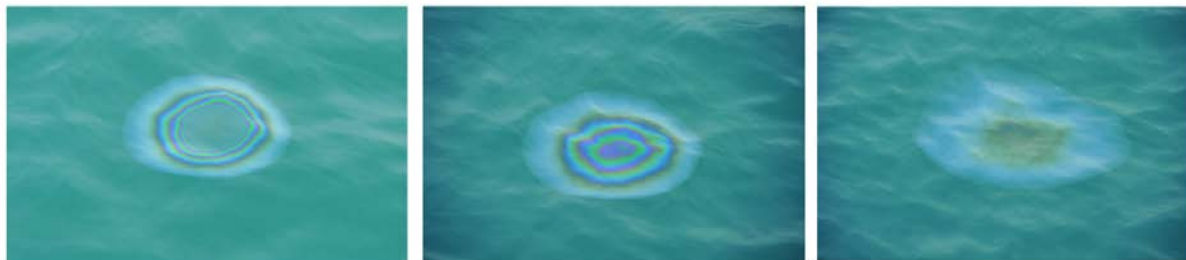
Figure 15. Three sequential images documenting a small oil seep over the DIVEX target as it rises to the surface of the water and disperses to form a small sheen.

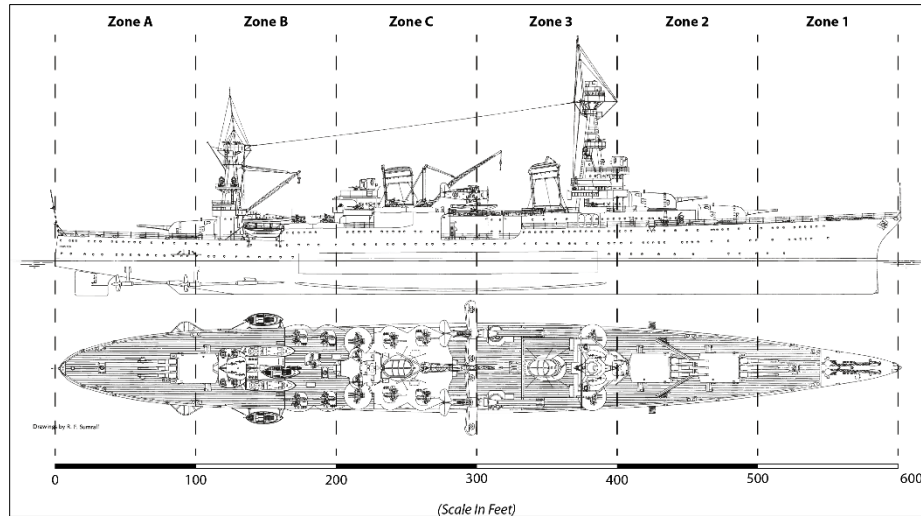
Schematic of USS *Houston* separated into six zones (A-C, 1-3), each 100FT (30.5M) wide, utilized early on in the survey to afford divers a means of documenting provenience and enabling methodical exploration of the site. Zones are designated alphabetically and numerically with their origins based on each extremity, the intended position of the first buoys to be placed on site.

These zones correspond to the entries presented above in the Transcribed Log of Diving Operations.
